# SmartBall<sup>®</sup> Inspection Report

## North Beach Force Main

(Inspection Date: Tuesday, August 23, 2011)

Prepared For:  
King County Wastewater Treatment Division  
201 South Jackson Street  
Seattle, WA, 98104

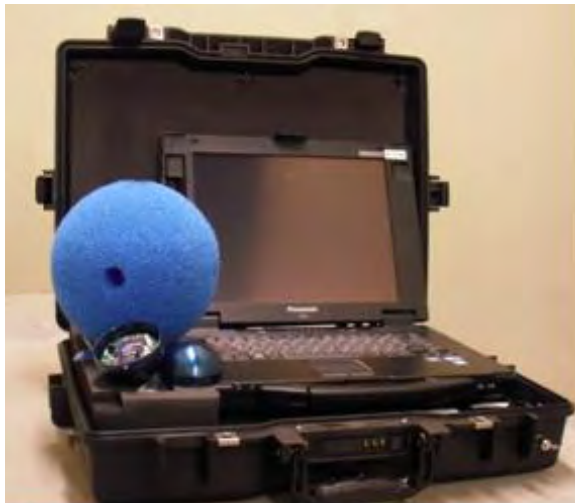
*Figure 2.1 – SmartBall core and foam shell with SmartBall Receiver (SBR)*

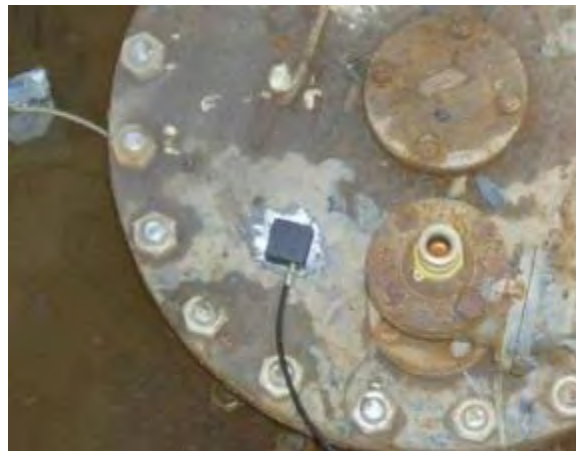
*Figure 2.2 – Acoustic sensor adhered to flange*

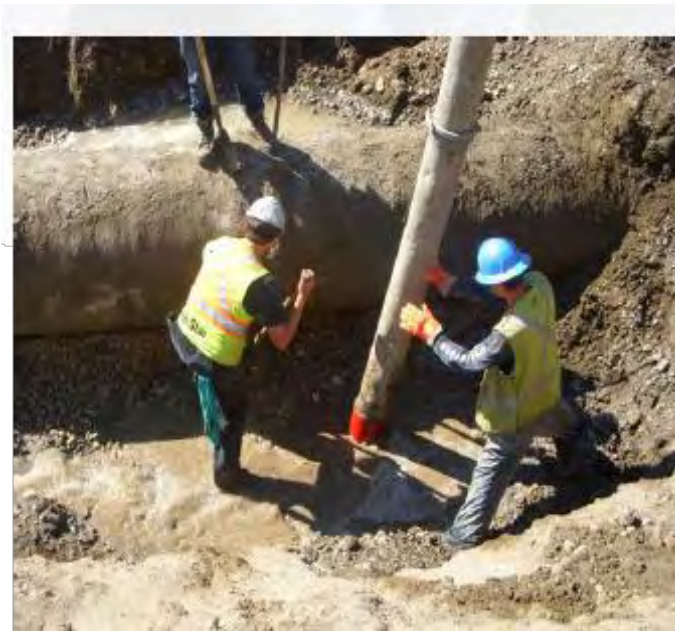
*Figure 2.4 – Example excavation to expose leaking joint*

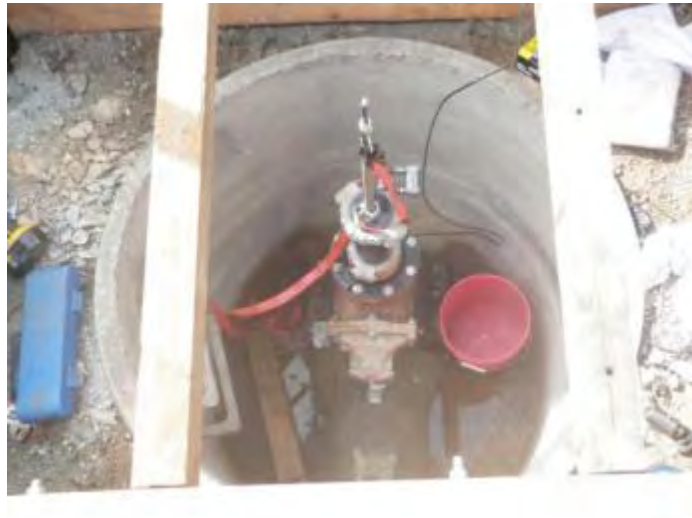
The insertion tool was used to keep the foam and SmartBall core contained as it is inserted through the client's 6-inch gate valve where it is then released into the flow.

*Figure 3.1 – Insertion site*

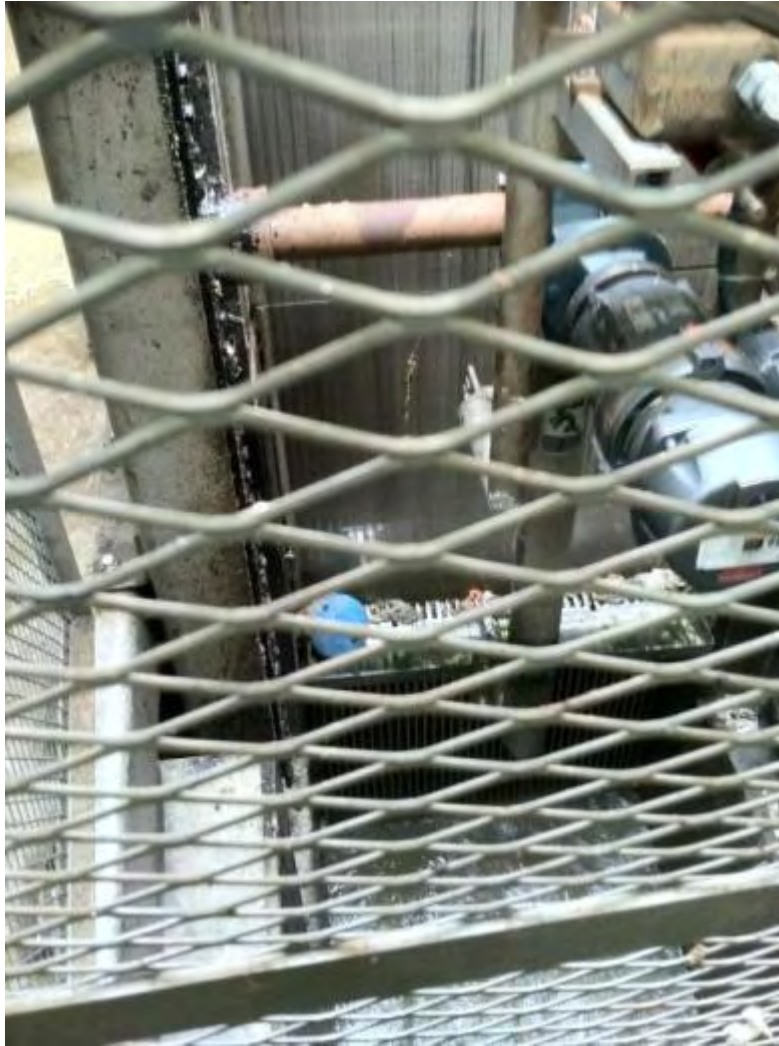
The SmartBall was extracted using a Bar Screen located inside the Carkeek Pumping Station and Store Weather Treatment Plant.

*Figure 3.3 – Extraction site*

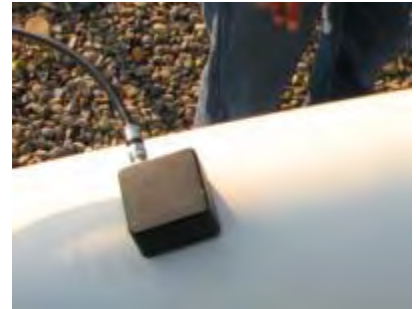
*Figure 3.5: Example of Sensor mounted to pipeline*

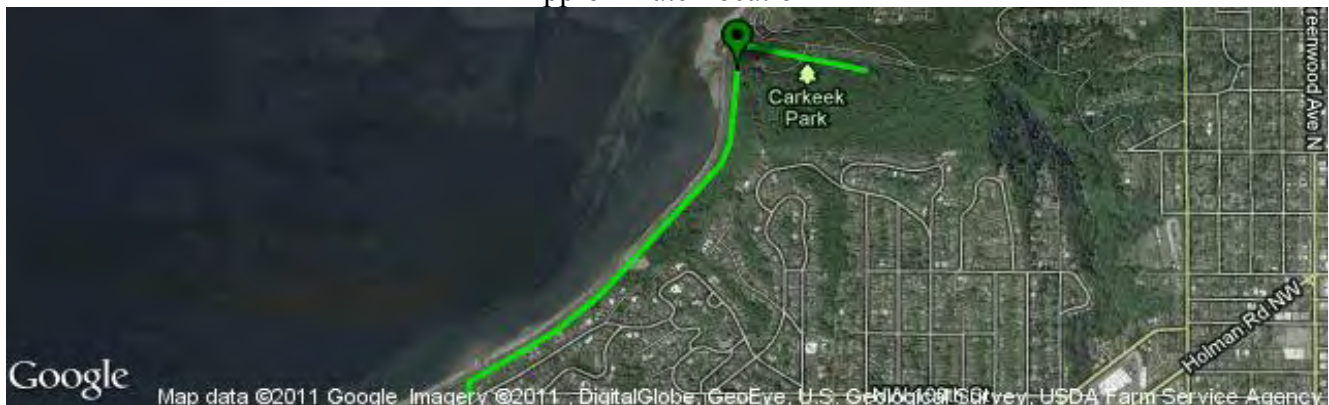
### Site of Interest #7 - Gas Pocket

Chainage at Location:	46+69
Distance to Nearest Sensor:	1,789.3 ft before Extraction
Distance from Insertion Point:	4,611.7 ft
Time Since Start of Rolling:	00:49:16
Time Since Activated:	03:22:37
Time of Tool Pass (GMT-8:00):	11:21:48 AM
Approximate Location: represent only approximate GPS location	47.7111, -122.3795 * *Based on Google Earth information which is as accurate as possible
Acoustic Profile of Leak: Use by Pure to Determine Approximate Leak Size	-49.5 dB (measured acoustically in decibels)
Estimated Size (Small/Med/Large): Based on proprietary algorithm and analysis of above quantification	~9ft

Figure 4.7c: Approximate Location of Acoustic Anomaly

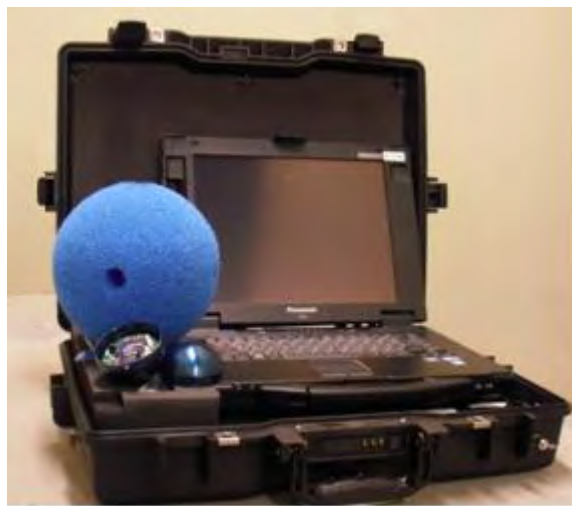
The SmartBall leak detection system consists of an inner aluminum alloy core containing an acoustic sensor and circuitry. The aluminum core is in turn encapsulated inside a foam ball. The foam ball provides the appropriate mass (size and overall weight) that allows the device to be propelled by the water flow. It also deadens any sound that the device might make as it traverses the pipeline. The foam ball and core are inserted into a fully flowing and operational pipeline and released to allow the flow to carry the ball downstream. While the ball is traversing the pipeline, it makes a continuous recording of all the acoustic activity in the pipeline. This data is later evaluated to determine the presence and location of any leaks or pockets of trapped gas.

A transponder within the SmartBall core emits high frequency, timed acoustic signals that are detected by proprietary SmartBall Receivers (SBR's) on the surface. The SBR's track the SmartBall's movement and location, correlating its position at any time in reference to acoustic events recorded on the acoustic sensor contained within the SmartBall.

*Figure 2 - SmartBall Core and Outer Foam Ball with SmartBall Receiver (SBR) unit*

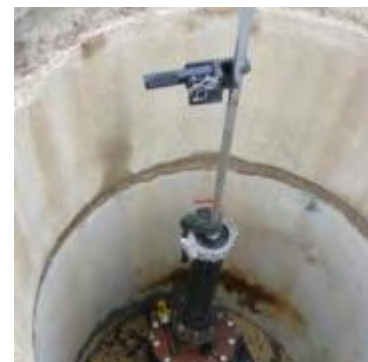
*Figure 3 - Insertion equipment used to insert SmartBall into a pipeline*

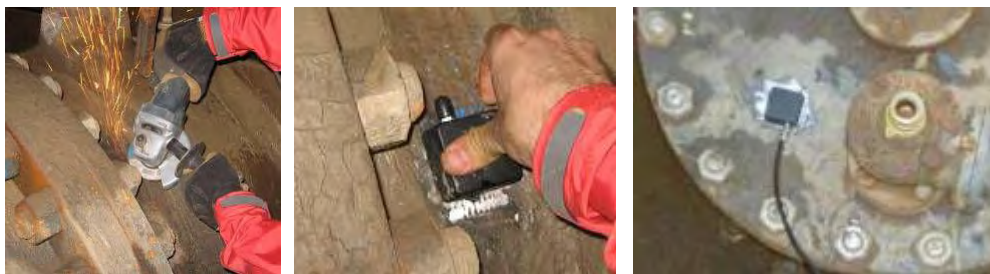
These sensors must be glued directly to a flange that is connected to the pipeline, or at the base of a riser connected directly to the pipeline. In general, this sensor site cannot be further than half of one meter (1 foot) from the flowing water of the pipeline, and not above any valve or other appurtenance that may inhibit the sensor from detecting the sound being transmitted from the SmartBall.

*Figure 4 – Acoustic sensor glued to flange*

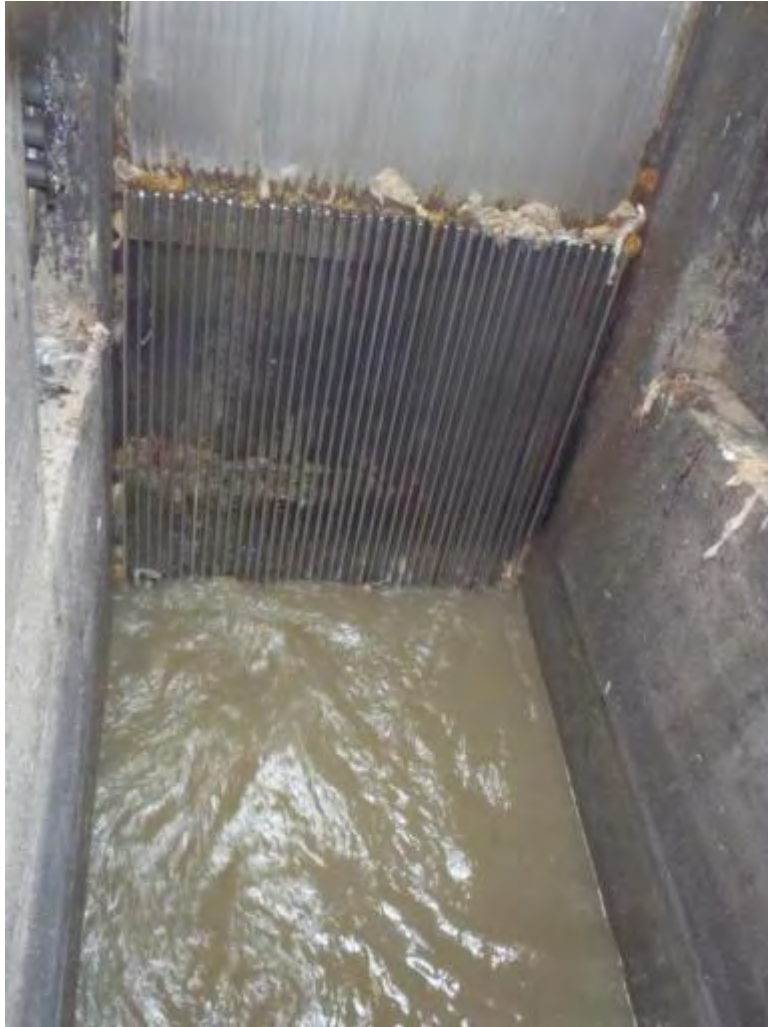
The SmartBall will be extracted via the bar screen and rakes located the Carkeek Pumping Station. Once the SmartBall arrives it will be raised out of the chamber by the automatic rake. The grinder used to dispose of material collected by the rake will be turned off during the inspection to prevent the SmartBall from being damaged.

*Figure87 –Extraction Chamber Photo (located at Carkeek Pumping Station)*
